## Device Errata

MPC850CE/D  
Rev. 3, 2/2003

MPC850 Device Errata  
Reference

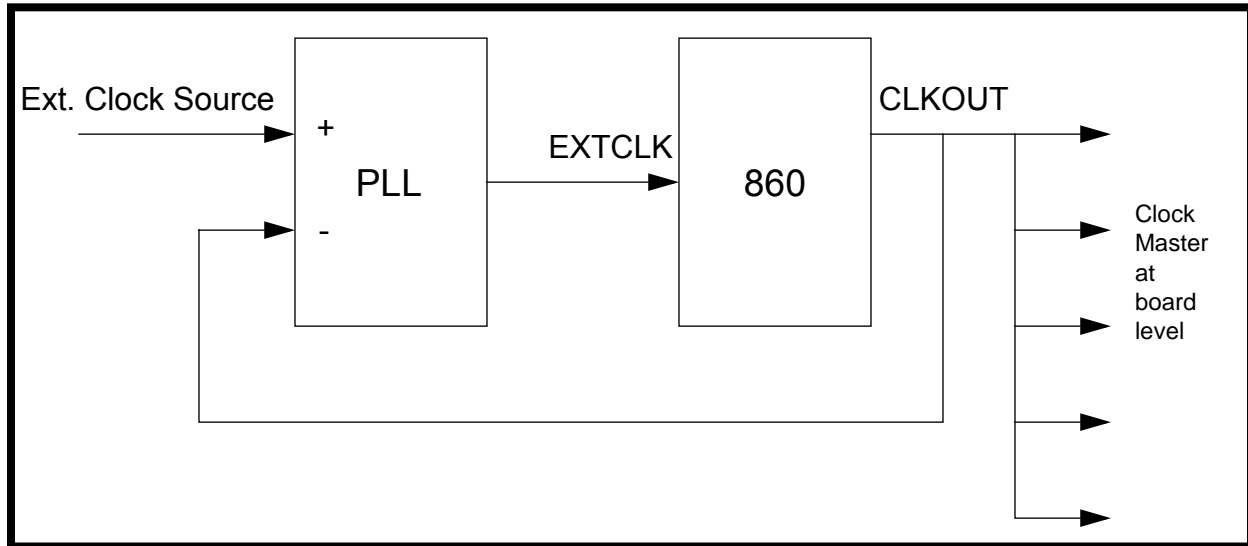
### **G4. Potential Problems Caused by Skew Between EXTCLK and CLKOUT.**

Important Note: The PLL has to be capable of operating with a permanent offset of -2nS, therefore the range of lock should extend to about -4nS.

A diagram of this concept is given below:
